Requester:	Versa Tables 14105 Avalon Blvd. Los Angeles, CA 90061
Contact Name / Number:	Jonathan Spicer / 310-353-7100 ext. 107
Dates Tested:	10/22/09 -10/28/09
Date Submitted:	10/29/09
Technician:	Jason Wisniewski, Jon Roblin
Customer Request I.D.	N/A

Scope: To test the 72" x 30" Junction table for BIFMA compliance. The 72" x 30" table was used for testing as it was deemed to be the worst case size. Model is also available in 30" x 30", 36" x 30", 48" x 30", and 60" x 30" sizes.

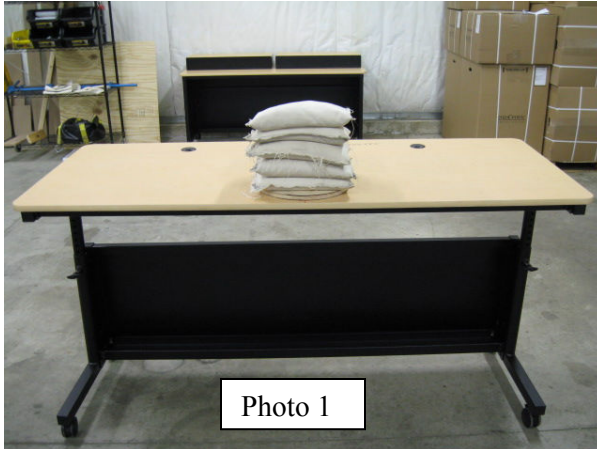
Photo 1

- Temperature / humidity 70° F / 44 RH%.
- 125 lb. load applied through a 12" disc.
- Disc position 1" in from the front edge, centered side to side.
- Test then repeated with the disc located 1" from the rear edge.
- See Photos 1 and 2 for set up.

<u>Specimen</u>	<u>Location</u>	<u>Observations</u>
1	Front edge	Unit did not tip over.
	Rear edge	Unit did not tip over.

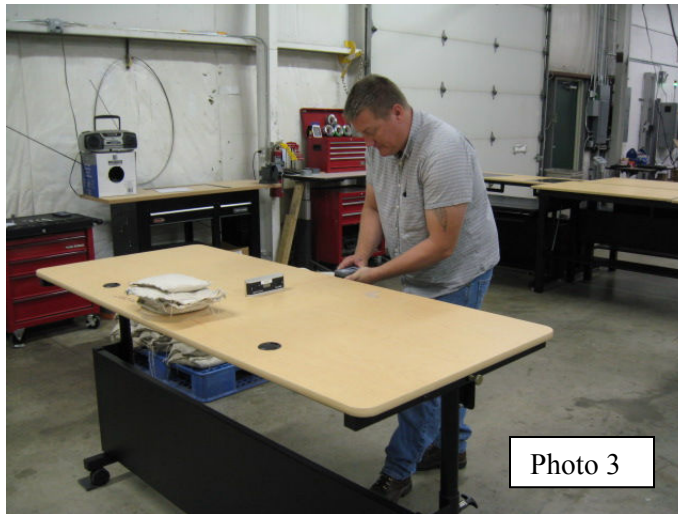
- Temperature / humidity 70° F / 44 RH%.
- Specimen placed at the highest adjustment point.
- 25 lb. load applied through an 8" disc.
- Disc positioned flush with the rear edge centered side to side.
- Horizontal force applied to the center of the front edge until 10 lbs. of force or 10° of tip was achieved.
- Test was then repeated with the disc located flush with the front edge.
- See Photo 3 for set up.

<u>Specimen</u>	<u>Disc Location</u>	<u>Observations</u>
1	Rear	10° angle reached. Unit did not tip over. Force to tip = 8.8 lbs
	Front	10 lb. force applied. Unit did not tip over.

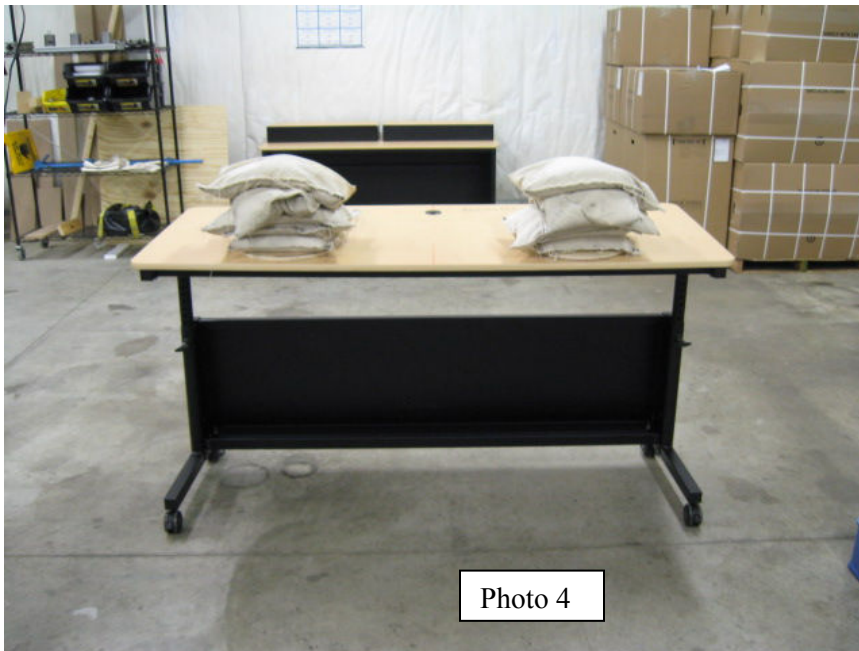
- Temperature / humidity 70° F / 44 RH%.
- Specimen placed at the highest adjustment point.
- Two 200 lb. loads applied through 12" discs centered 36" apart, 1" in from the front edge.
- Load applied for 60 minutes.
- See Photo 4 for set up.

<u>Specimen</u>	<u>Load (lbs.)</u>	<u>Time (min.)</u>	<u>Observations</u>
1	2 x 200	60	No loss of serviceability.

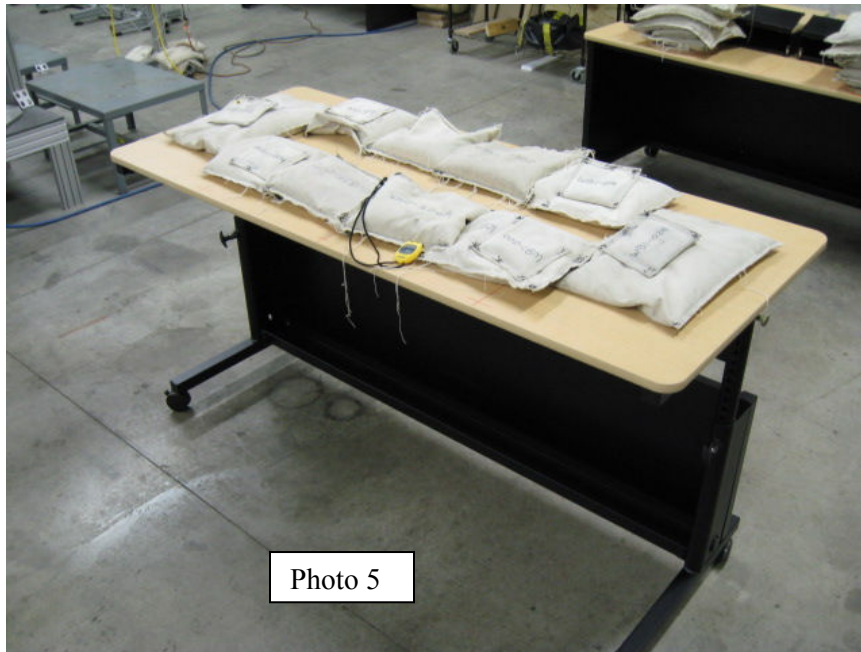
- Temperature / humidity 70° F / 44 RH%.
- Specimen placed at the highest adjustment point.
- 204" of perimeter x 1.5 = 306 lbs.
- Load applied on a line 8" in from the edge around the entire perimeter.
- Load applied for 60 minutes.
- See Photo 5 for set up.

<u>Specimen</u>	<u>Load (lbs.)</u>	<u>Time (min.)</u>	<u>Observations</u>
1	306	60	No loss of serviceability.

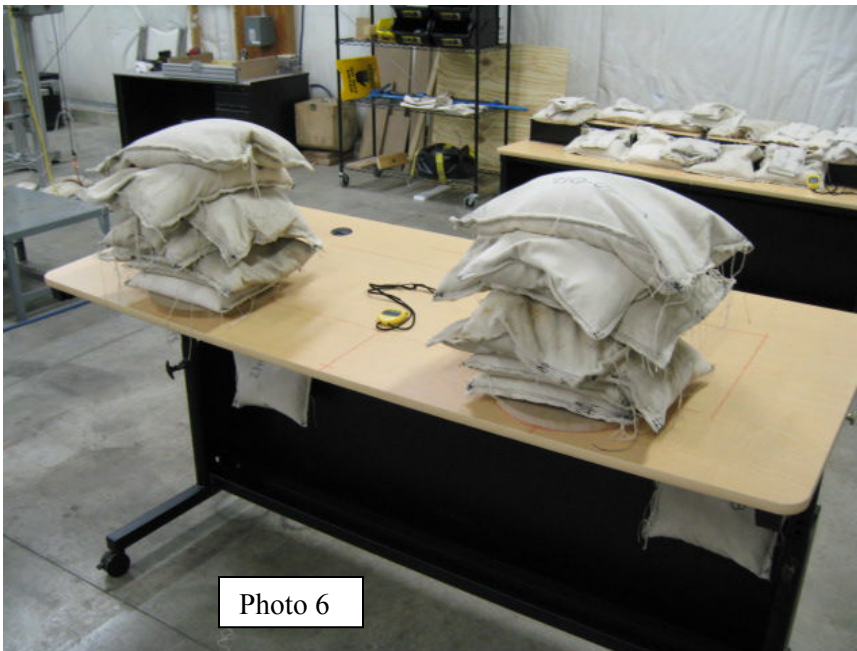
- Temperature / humidity 70° F / 44 RH%.
- Specimen placed at the highest adjustment point.
- Two 300 lb. loads applied through 12" discs centered 36" apart, 1" in from the front edge.
- Load applied for 15 minutes.
- See Photo 6 for set up.

<u>Specimen</u>	<u>Load (lbs.)</u>	<u>Time (min.)</u>	<u>Observations</u>
1	2 x 300	15	No sudden and major change in structural integrity.

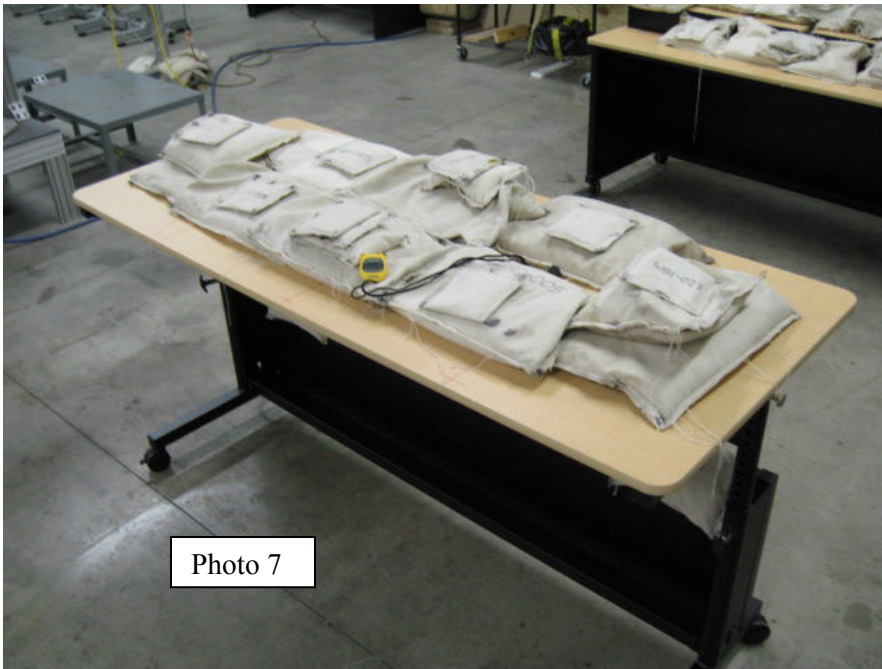
- Temperature / humidity 70° F / 44 RH%.
- Specimen placed at the highest adjustment point.
- 204" of perimeter x 2.3 = 469 lbs.
- Load applied on a line 8" in from the edge around the entire perimeter.
- Load applied for 15 minutes.
- See Photo 7 for set up.

<u>Specimen</u>	<u>Load (lbs.)</u>	<u>Time (min.)</u>	<u>Observations</u>
1	469	15	No sudden and major change in structural integrity.

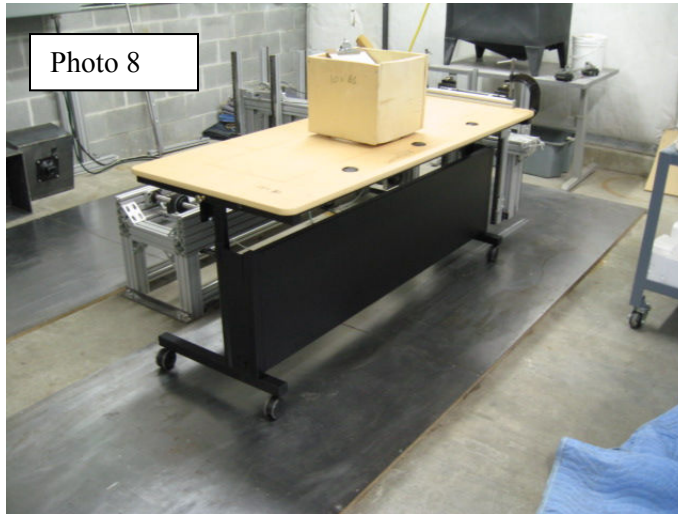
- Temperature / humidity 70° F / 46 RH%.
- Specimen placed at the midpoint of adjustment.
- Based on weight (118.5 lbs.), specimen was subjected to 100 cycles over 1/8" thresholds, then 1,000 cycles over a smooth plate.
- 85 lb. load applied to the center of the top through a 12" disc.
- 11 cycles per minutes.
- See Photo 8 (smooth plate) for set up

<u>Specimen</u>	<u>Cycles</u>	<u>Observations</u>
1	0	Test begun over thresholds.
	100	No loss of serviceability. Thresholds removed
	100	Test resumed with thresholds removed.
	1,100	No loss of serviceability.

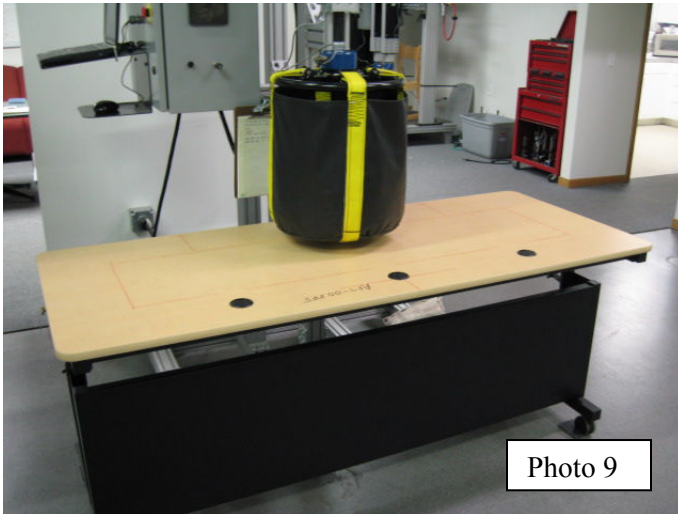
- Temperature / humidity 68-70° F / 45 RH%.
- Specimen placed at the midpoint of height adjustment.
- 200 lb. load applied through a 16" bag.
- Bag position 1" in from the front edge, centered side to side.
- Load applied without impact and removed once per cycle.
- 10,000 cycles at a rate of 18 cycles per minutes.
- See Photo 9 for set up.

<u>Specimen</u>	<u>Cycles</u>	<u>Observations</u>
1	0	Test begun.
	10,000	No loss of serviceability.
